traffic safety

SPECS SAFETY CAMERAS – SOUTH YORKSHIRE

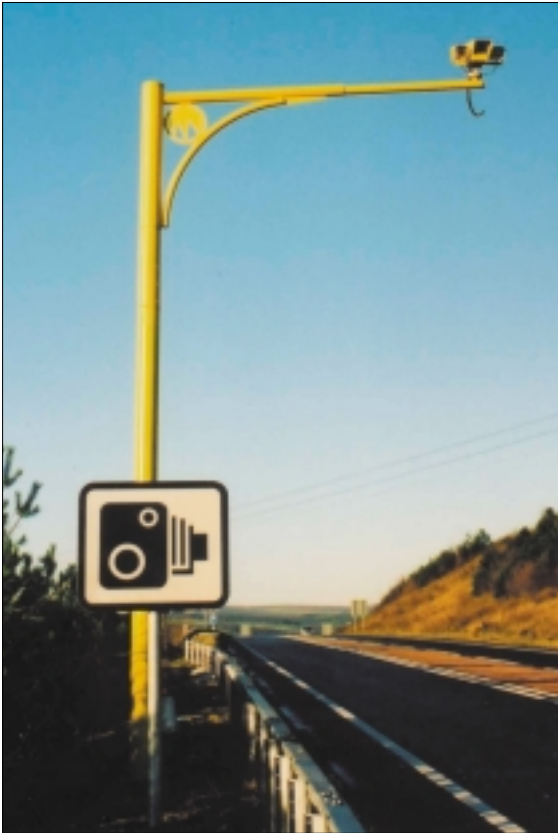
Eight SPECS pairs have been in operation on the A616 since December 2003. Each SPECS pair consists of two digital video cameras, linked by fibre optic cable to a remote enforcement cabinet. The video cameras continuously capture images of vehicles as they pass through the cameras' views. The number plates are read using Automatic Number Plate Recognition (ANPR) and the average speed of the vehicle is calculated between the two cameras. If this exceeds the Police threshold, a violation file is created.

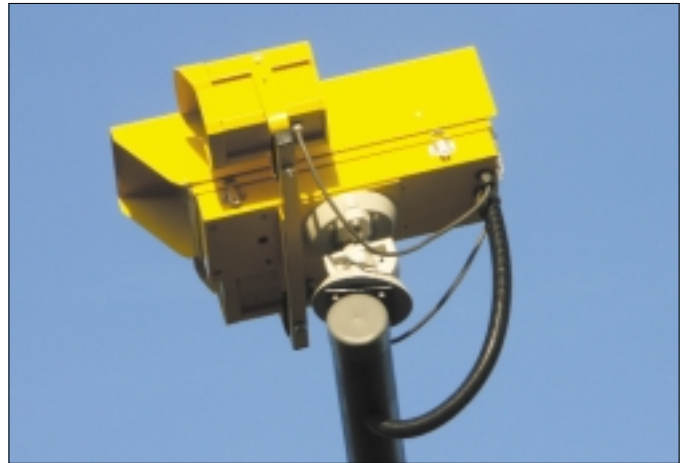
The SPECS camera pairs are clearly erected on unique bright yellow single armed columns. In conjunction with rumble strips and speed limit markings on the road, the camera columns create very noticeable gateways to the 'speed control zone', with repeat columns acting as a powerful reminder to drivers that they are inside a speed monitored area.

Over the 11km stretch, the cameras provide a route strategy approach, modifying driver behaviour over the entire distance.
